Volusia Blue Spring Restoration Plan

Janna Hall
UF#38113669
ENV 6932K Fall 2010

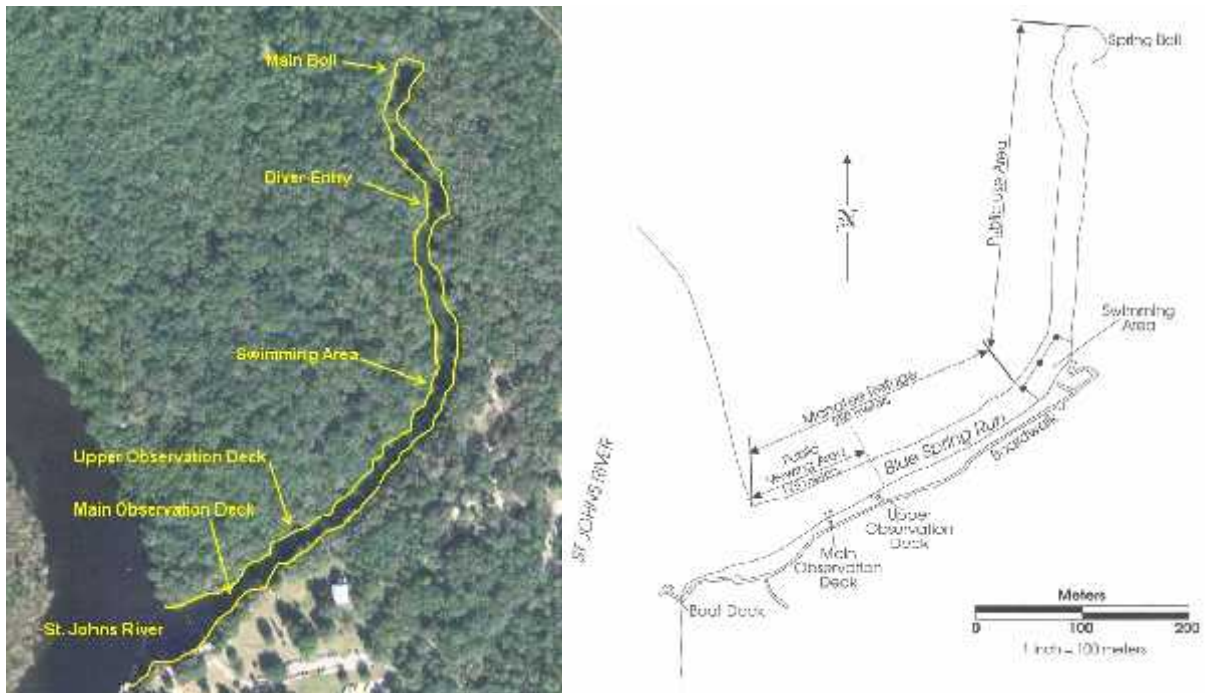
Figure 1.1 Blue Spring State Park (WSI, 2009)

Volusia Blue Spring is considered the largest spring along the St Johns River (SJWMD, 2010). The main spring pool at Blue Spring State Park is 135 ft by 100ft with a sandy limestone bottom and steep sandy banks, presented in Figure 1(SJWMD, 2010). The main spring vent is a narrow cave opening that drops vertical 60 feet and then continues at a 45 degree angle to a depth of 120 ft (USGS, 2008). Cave divers are allowed to dive the first 60 ft and then access is restricted (USGS, 2008). There are numerous tunnels that extend from the main vent with no outlets, as depicted in Figure 1.2 (SJWMD, 2010). The southern end of the spring pool opens into Blue Spring run which flows 0.5 miles south southwest into the St Johns River (SJWMD, 2010). The width of the spring run is 80-100 ft and is surrounded by hardwood and palm forest (FGS, 2004).

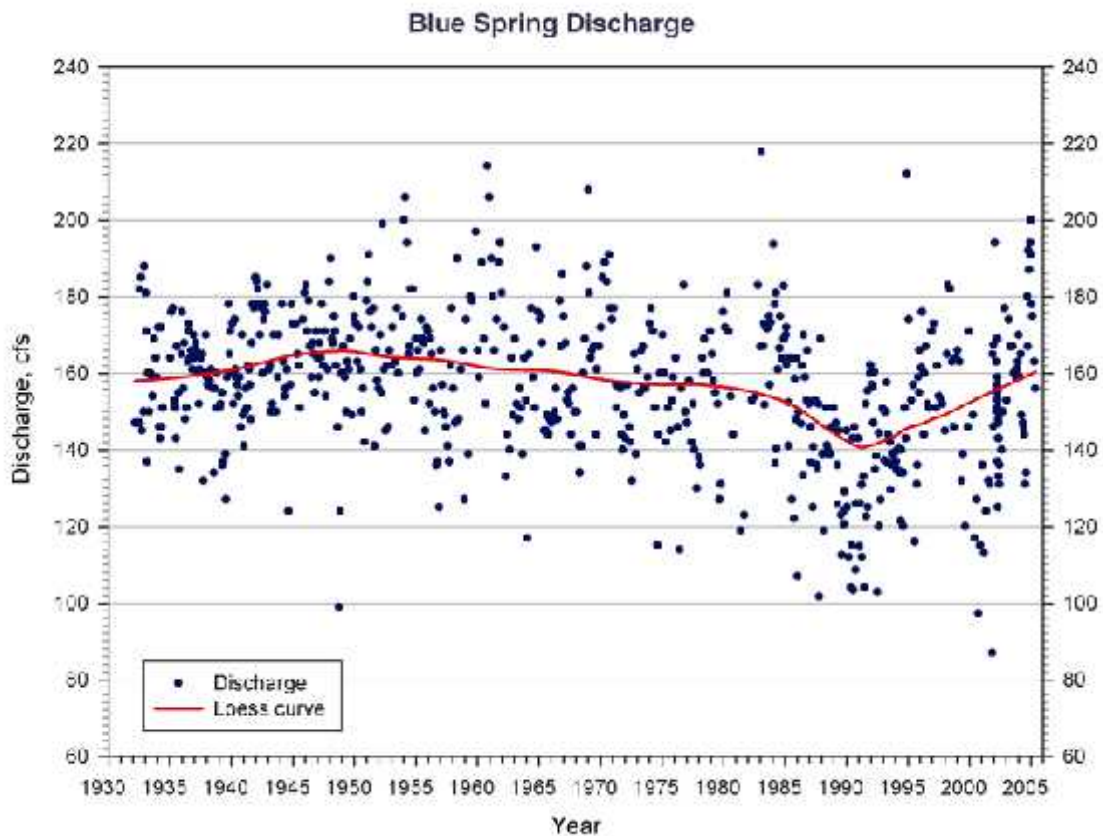
**Figure 1.3 Discharge in cubic feet per second from 1932 to 2005
(SJWMD, 2010)**

Volusia Blue Spring is considered a first magnitude spring with an average mean flow of 157cfs (SFWMD, 2010). Discharge measurements have been recorded as early as the 1930's and provide a detailed summary of the history of flows. Between 1932 and 2005 the maximum discharge of 218 cfs occurred in February 1983 and the lowest discharge measured 87 cfs occurred in November 2001 (SJWMD, 2010). These variable flow rates are affected mainly by localized rain events and groundwater consumption.

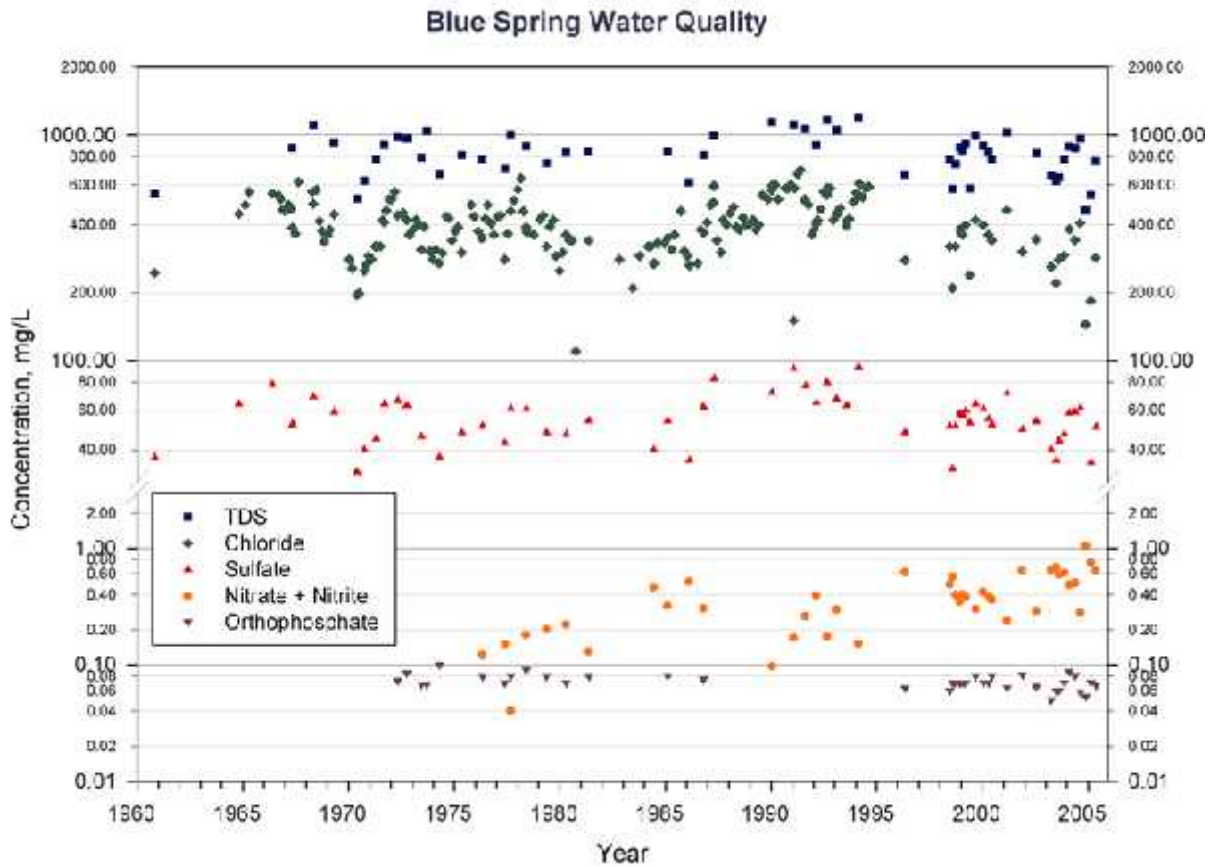
Figure 1.4 Water Quality concentrations from 1960-2005 (SJWMD, 2010)

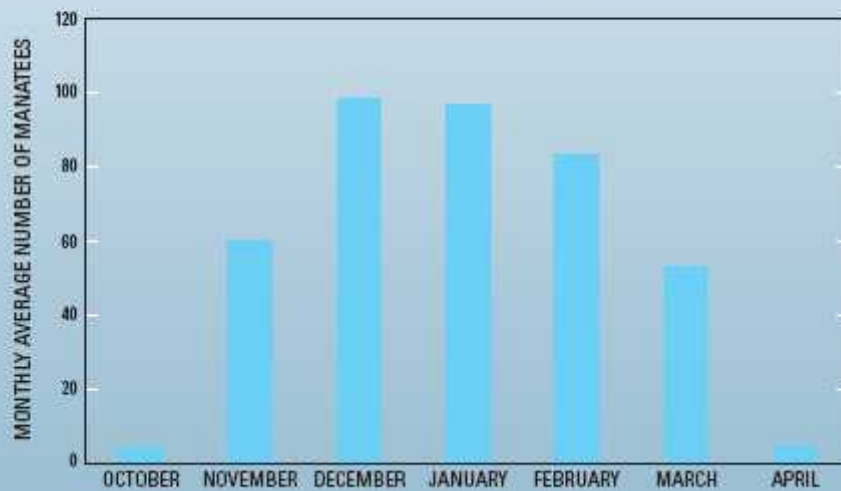
Figure 8. Monthly average manatee population of Blue Spring run. (Number refers to average number of manatees observed in the run from 1983 to 2007. Data furnished by the Blue Spring State Park.)

Figure 1.5 Manatee population in Blue Spring run from 1983-2007 and monthly average of manatee numbers (German, 2008)

The West Indian Manatees were declared endangered in 1973 by the U.S. Endangered Species Act and the U.S. Marine Mammal Protection Act of 1972 (www.wikipedia.com). Protection efforts succeeded and in 2007 the U.S. Fish and Wildlife reclassified the West Indian manatee as threatened due to increases in population (www.wikipedia.com). Evidence of the growing population can be seen every year at Blue Spring as more manatees inhabit their winter refuge, see Figure 1.5 (German, 2008). The USGS estimates that the number of manatees that visit the spring every year have increased from than 60 in the mid 1980's to over 250 in 2007 (German, 2008).

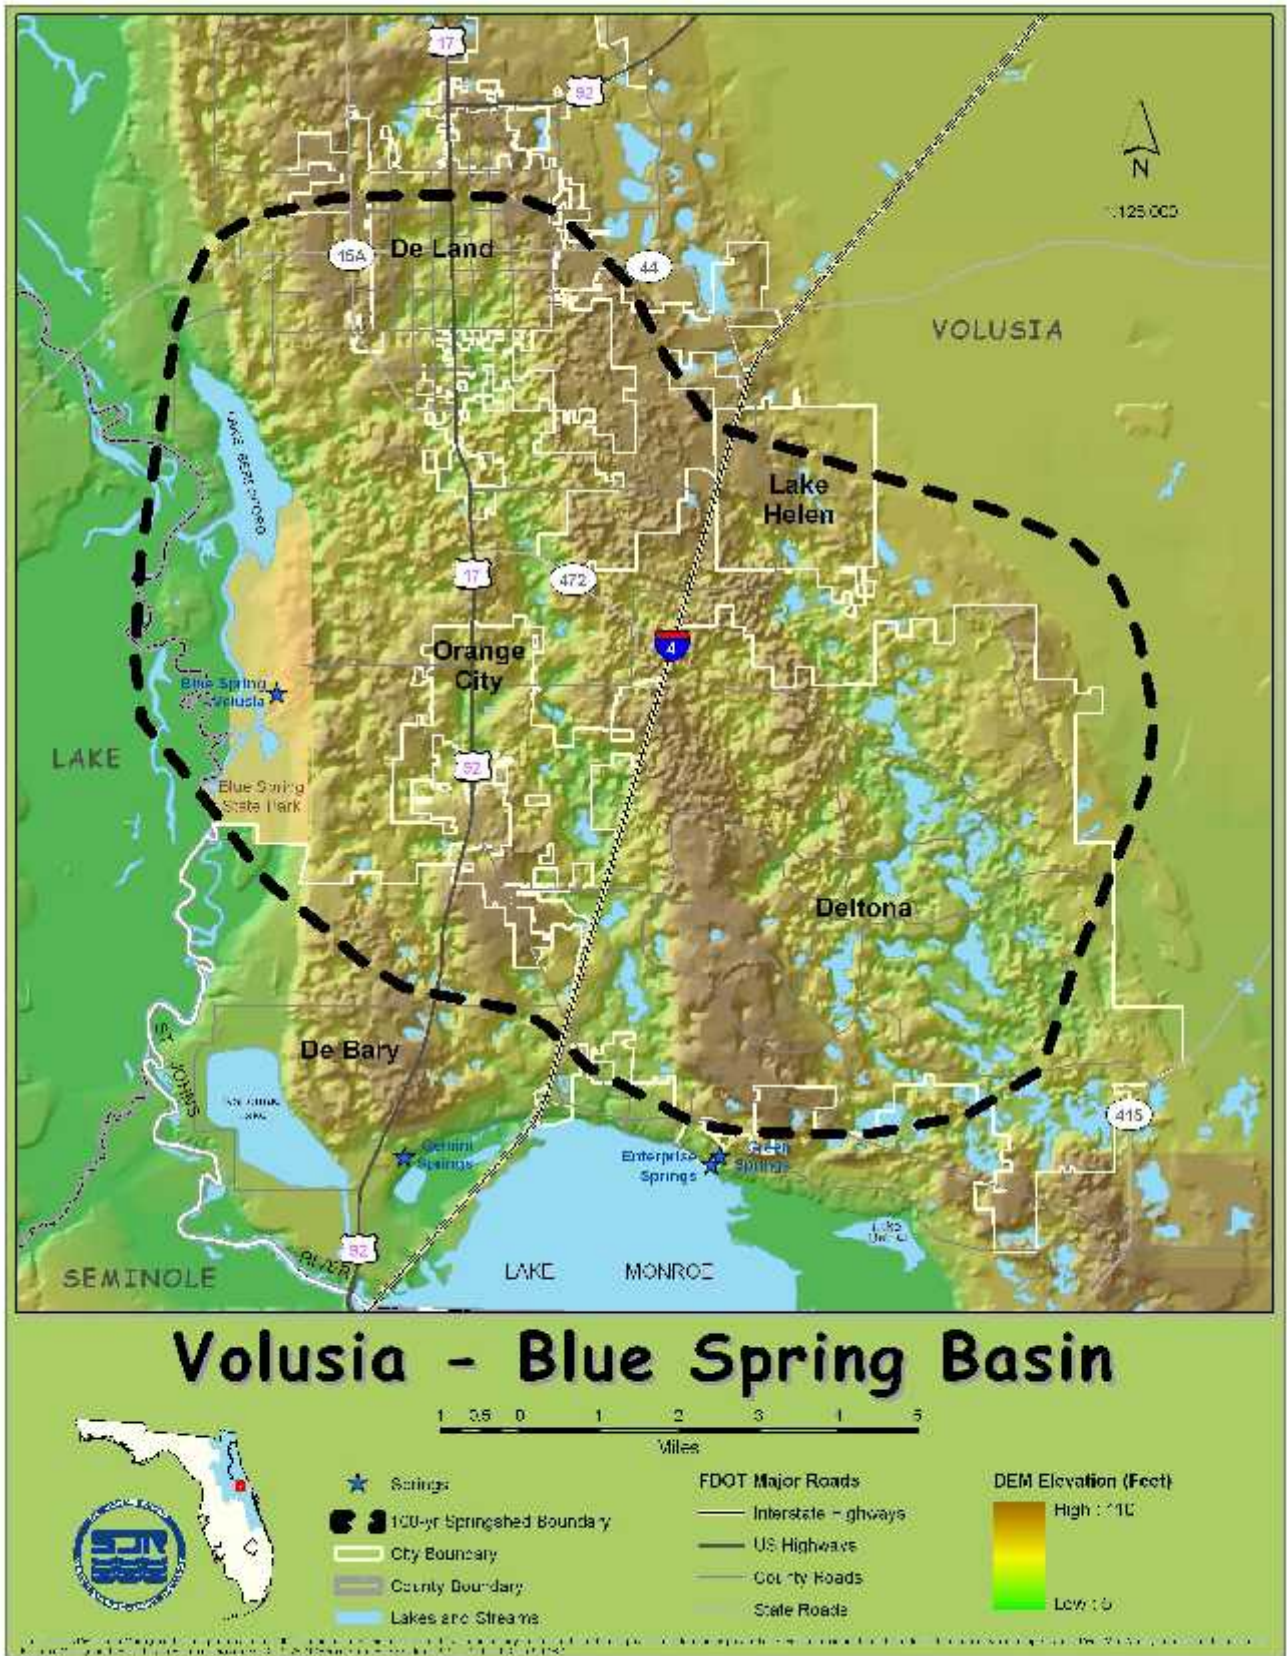
Figure 2.0 Blue Spring Basin (Stokes, 2008)

The USGS defines a springshed as areas within ground and surface water basins that contribute to the discharge of the spring (German, 2008).). Based on multiple ground-water flow models, the composite area for the spring-shed of Blue Spring in Volusia County is 130 square miles (Shoemaker *et al.*, 2004). The majority of the recharge area is located east of the spring in the vicinity of Deltona, Orange City, and Deland (Shoemaker *et al.*, 2004). Two of the three models predicted a small area west of the St John's River in Lake County to contribute recharge to the spring as shown in Figure 2.4. However, further examination shows ground-water flow discharging in the St John's River with possible surplus flow continuing under the river to discharge at Blue Spring (Shoemaker *et al.*, 2004). The same study used backward tracking analysis to determine that 45-80% of the total discharge of Blue Spring reaches the spring within 100 years. This indicates that present day water quality may be influenced by water that entered the aquifer decades before (German, 2008).

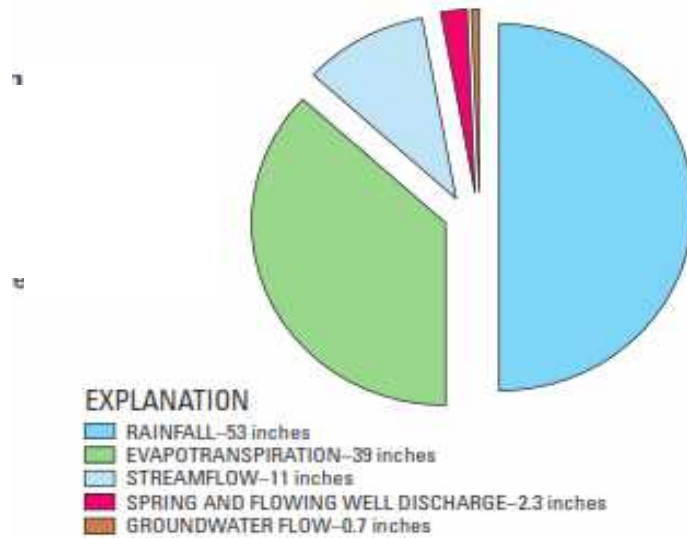
Figure 2.6 Annual Water Budget in Volusia County (German, 2009)

The water cycle in Volusia County consists of an average annual rainfall of 53 inches, evapotranspiration loss of 38 inches, streamflow loss of 11 inches, spring and flowing well discharge of 2.3 inches, and groundwater flow loss of 8.7 inches, see figure 2.6 (German, 2009) . The amount of water stored in the atmosphere, surface water or ground water is constantly changing and is impacted by human use, see Figure 2.7 (German, 2009). Human uses that alter the flow or storage of surface water and ground water include irrigation in agriculture and domestic uses. Water used in irrigation that is not consumed by plants can be returned to the ground water or to the atmosphere by transpiration (German, 2009). Water used for domestic purposes is either consumed or returned as wastewater in sewage treatment facilities or septic tanks (German, 2009).

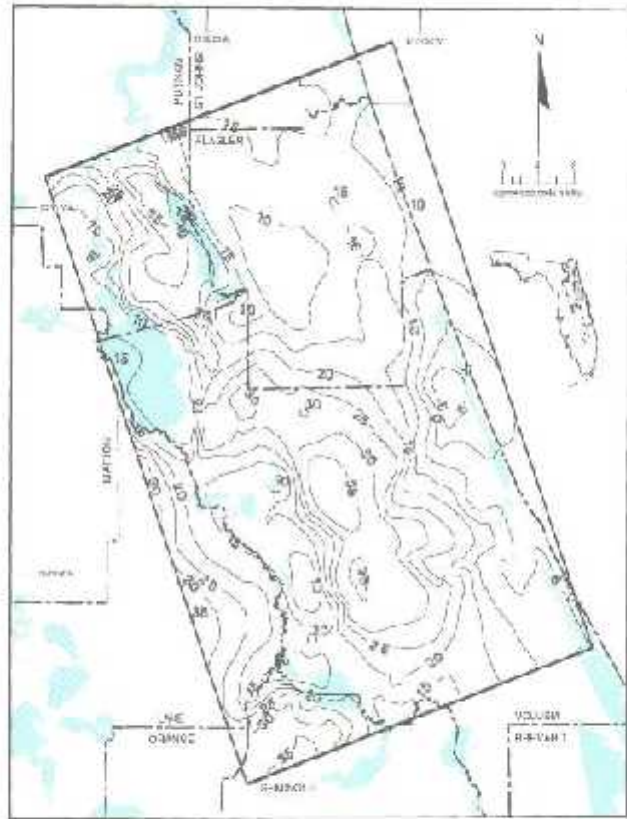
Figure 6. The average 1988 potentiometric surface of the Upper Floridan aquifer (Schiner 1980, Nodes 1982)

Figure 2.10 Average Potentiometric surface of The Upper Floridan Aquifer in 1988 (McGurk, 1998)

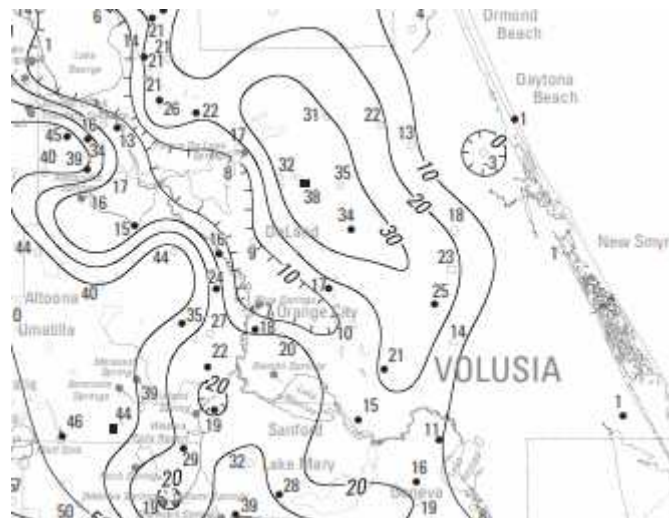
Figure 2.11 Potentiometric surface of the Upper Floridan Aquifer in Volusia County for May 2009 (Kinneman and Dixon 2009)

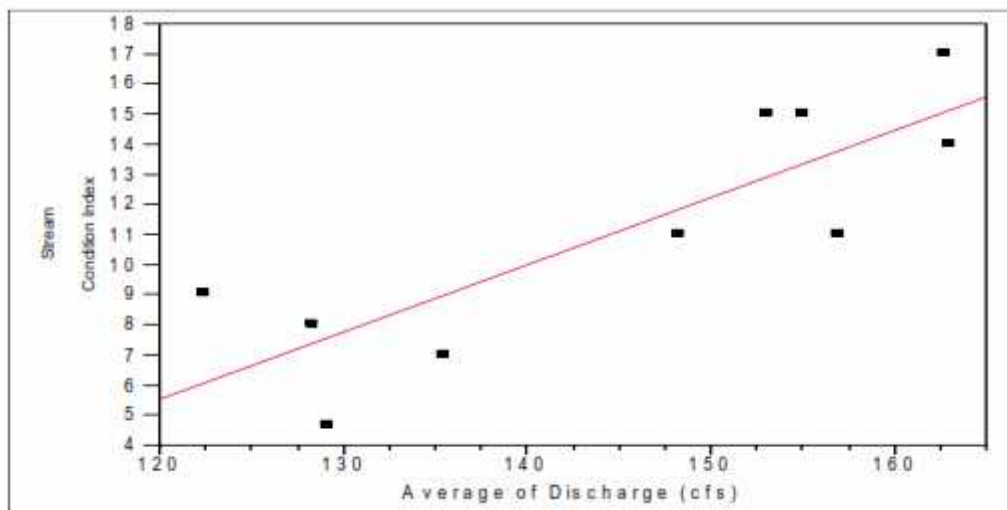
Figure 3.2 Relationship of SCI to average spring discharge from 2000 to 2008 (WSI, 2009)

Macro-invertebrate populations as measured by the Stream Condition Index (SCI) also show a positive correlation to spring discharge, Figure 3.2 (WSI, 2009). As the discharge decreases the SCI index decreases. SCI values of Blue Spring range from 4-15 on a scale of 100, which designates Blue Spring as being impaired (0-34) (FDEP, 2009). In conjunction with discharge rates, macro-invertebrate communities are also affected in Blue Spring by low dissolved oxygen, elevated conductivity, and increased algal populations (FDEP, 2009).

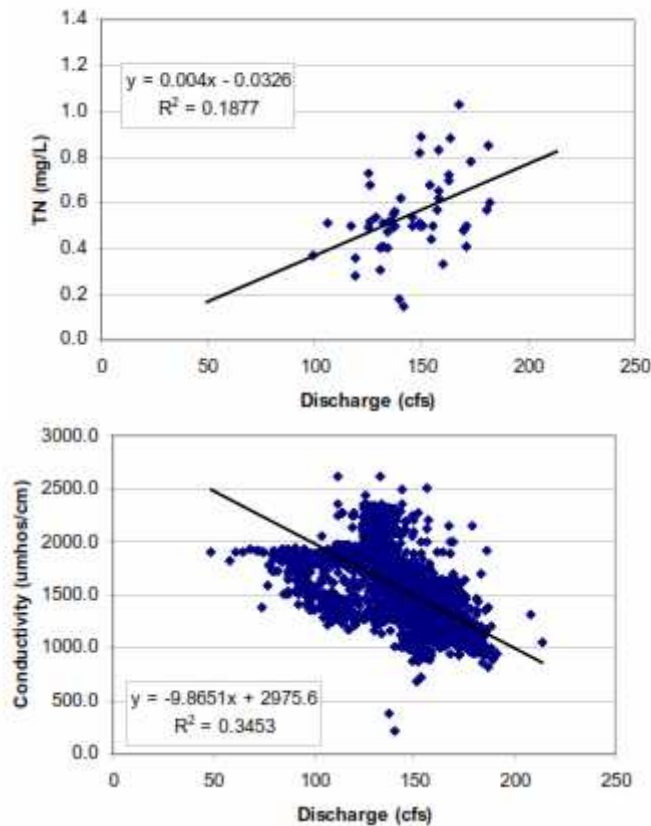
Figure 3.3 Relationships of total nitrogen and conductivity to spring discharge (WSI, 2009)

Parameters of water quality such as total nitrogen are positively correlated to discharge whereas conductivity shows a negative correlation and the pH and temperature remain relatively stable, Figure 3.3 (WSI, 2009). Higher concentrations of conductivity are indicative of older water from the Upper Floridan aquifer which is generally expressed when the potentiometric surface is low. The increasing total nitrogen with increased discharge is indicative of more recent water from the aquifer. As management practices and efforts to reduce nitrogen loading in the spring basin begin to take effect, which could take decades to show, total nitrogen concentrations may become more reduced with increased discharge.

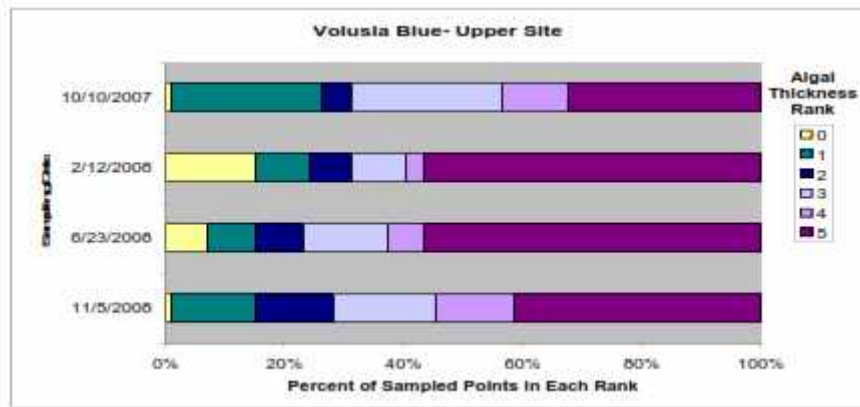
Figure 3.4 Filamentous algae thickness for Upper Blue Spring Run (FDEP, 2009)

Algal thickness in Blue Spring run was greatest near the spring boil at the upper and middle stations and not as abundant at the lower station, as shown in Figures 3.4, 3.5, and 3.6 (FDEP, 2009). The upper and middle stations measured greater than 20mm of algal thickness and dominated the periphyton community (FDEP, 2009).

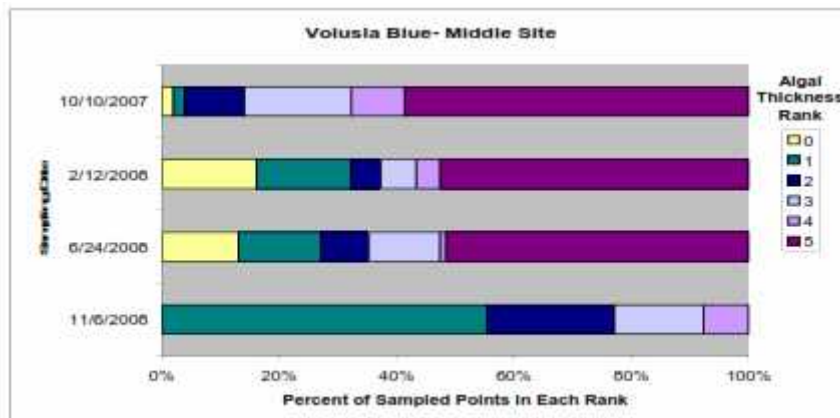
Figure 3.5 Filamentous algae thickness for Middle Blue Spring Run (FDEP, 2009)

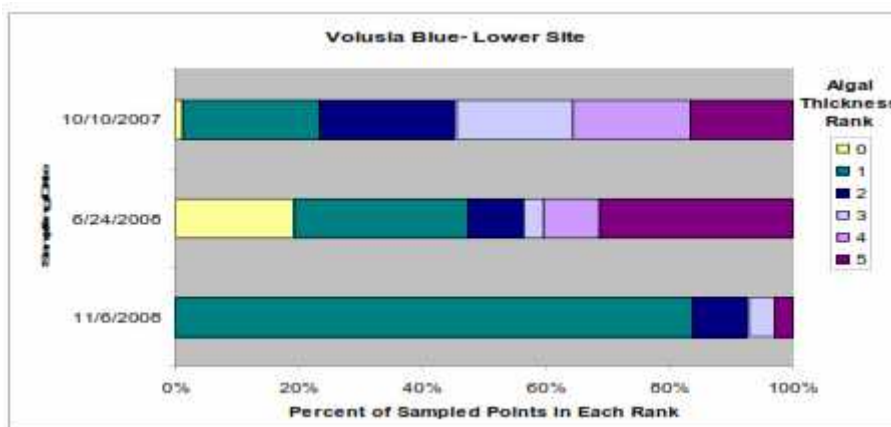
Figure 3.6 Filamentous algae thickness for Lower Blue Spring Run (FDEP, 2009)
